LANDSLIDE PROTECTION OF ROADWAY NETWORK DURING THE CONSTRUCTION AND RECONSTRUCTION

Vladimir Polcanov, ORCID: 0000-0001-8389-2128,
Alina Polcanova, ORCID: 0000-0001-5826-8278,
Alexandru Cîrlan*, ORCID: 0000-0003-4009-2790

Technical University of Moldova, 168 Stefan cel Mare Blvd., Chisinau, Republic of Moldova

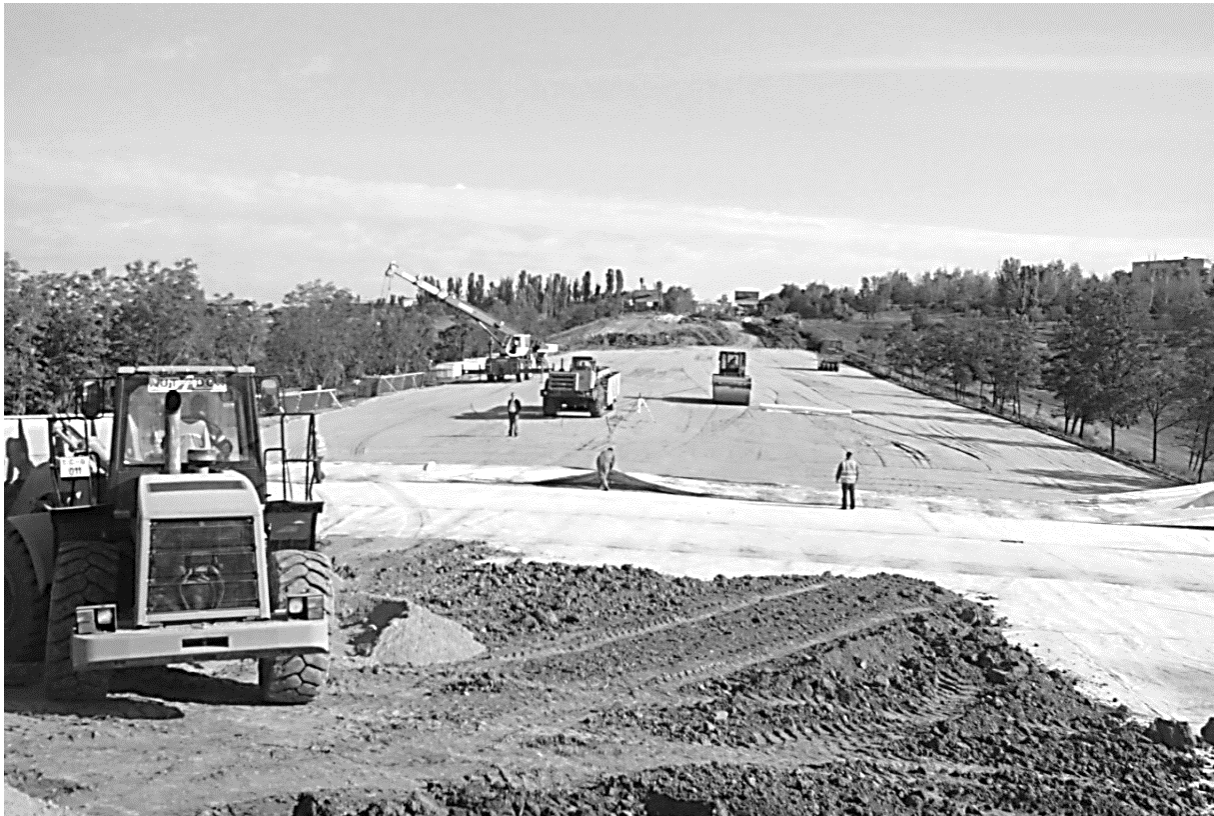
Figure 1. Restoration work at a site of embankment bypassing the town of Ialoveni.

- Capping layer soil cut and fill to a depth of 3.0 - 5.0 m;
- Works concerning assurance of impermeability and frost resistance of soils, which compose the road border and located immediately below road topping;
- Works concerning assurance of water disposal and surface water controls;
- Works concerning groundwater flow control (setup of groundwater cutoff);
- Change of slope gradients;
- Reinforcement of ramps through sowing grass, by planting vegetation with an advanced root system, which slows down the advancing of erosional-landslide processes.

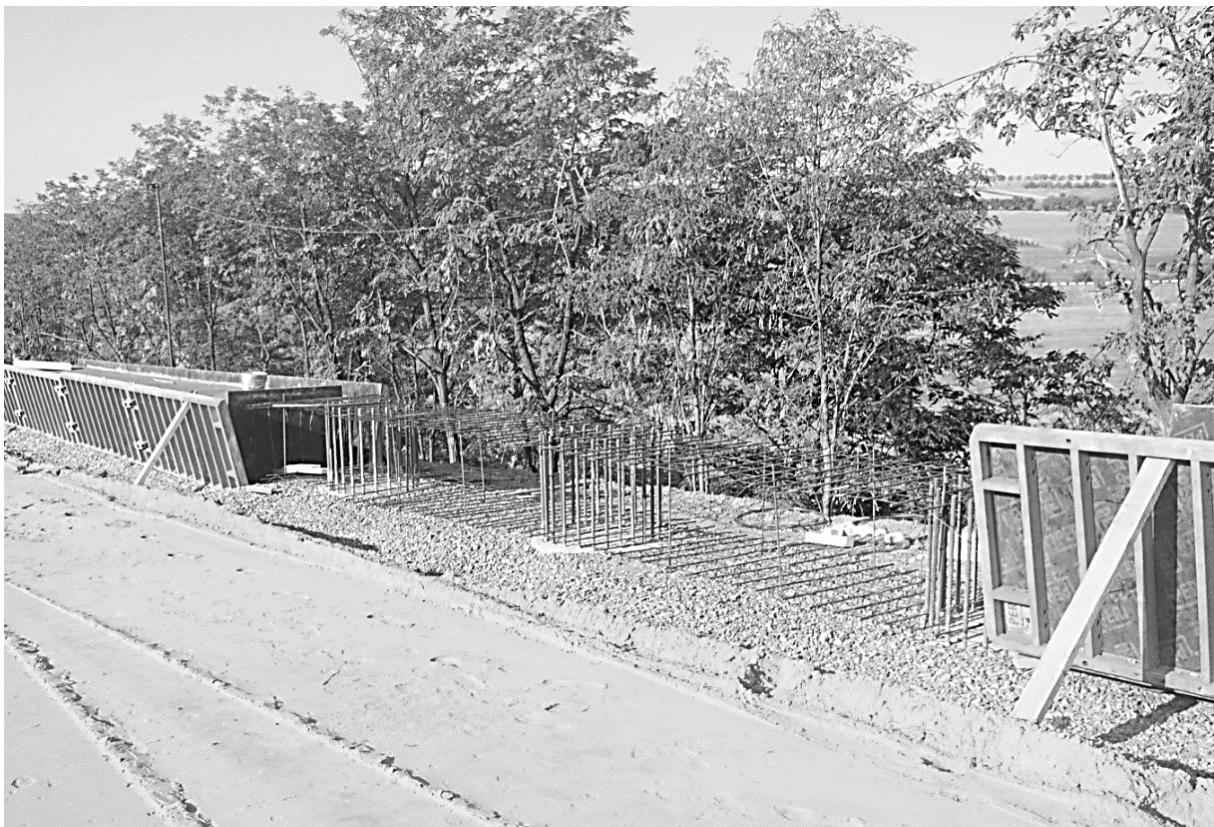
Figure 2. Arrangement of bored piles in the right slope of the embankment.

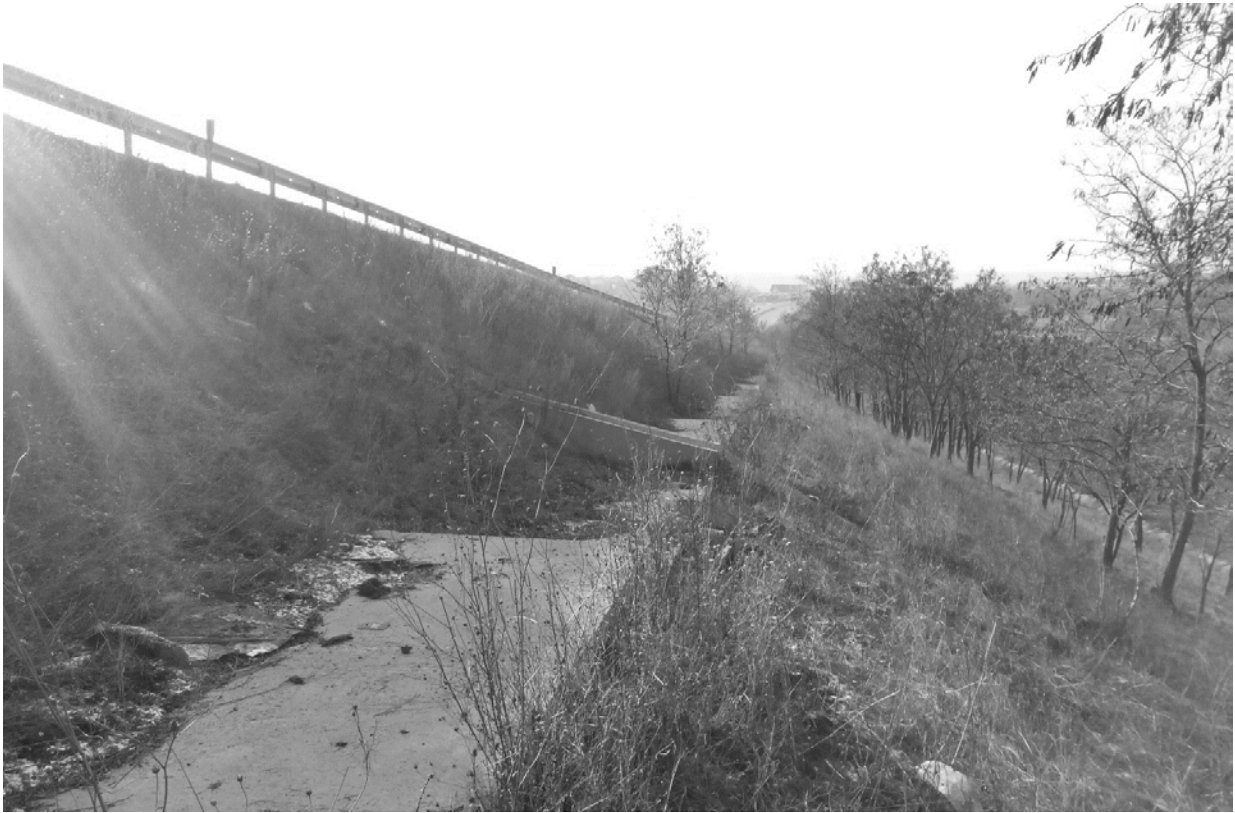
Figure 3. Section of embankment in December of 2019.

In December of 2019, the authors of this work carried out a visual inspection of the embankment section and performed works. It showed that there are no significant deformations in the mass of the embankment. However, in some spots, in the surfacing, there are longitudinal and transversal cracks opening up to 2 cm wide (Figure 5, 6). The origin of the cracks can be explained by the unfinished consolidation of the newly filled soils and, presumably, by the insufficient rigidity of the road material.

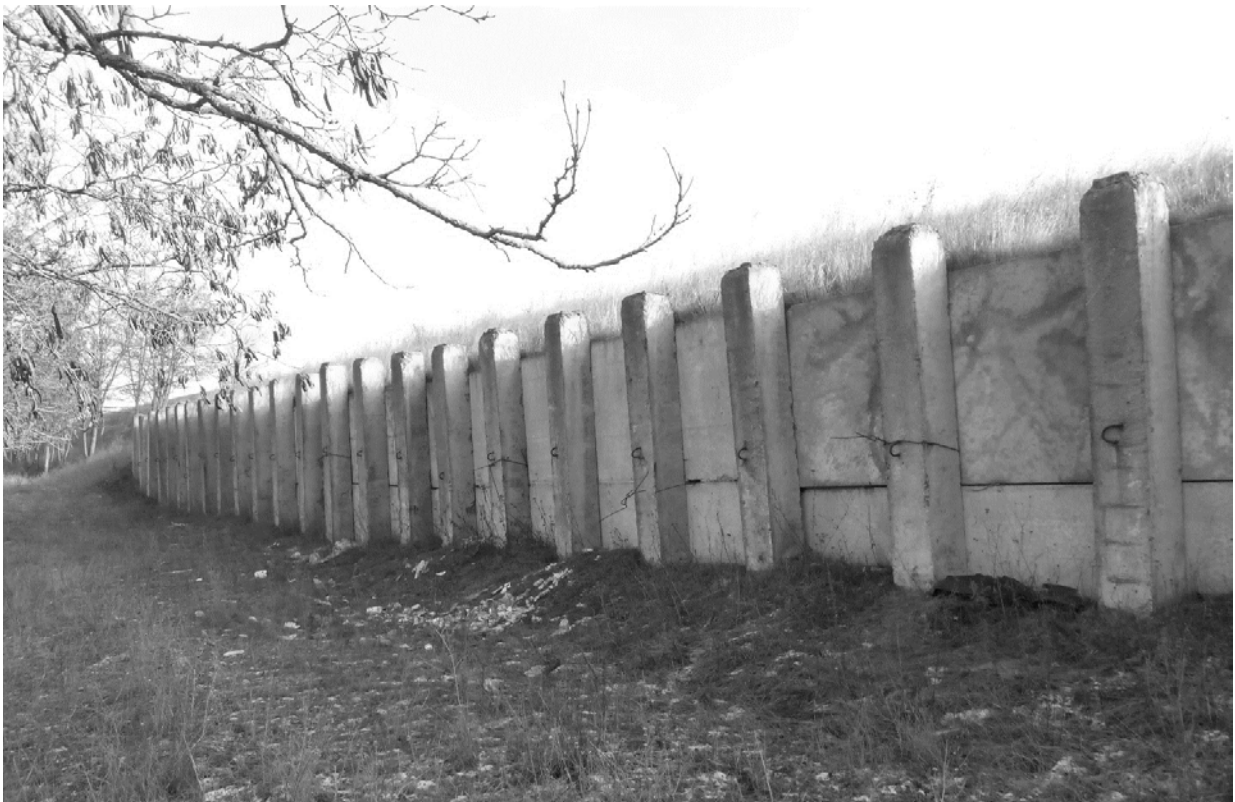
Figure 4. Section of embankment in December of 2019.

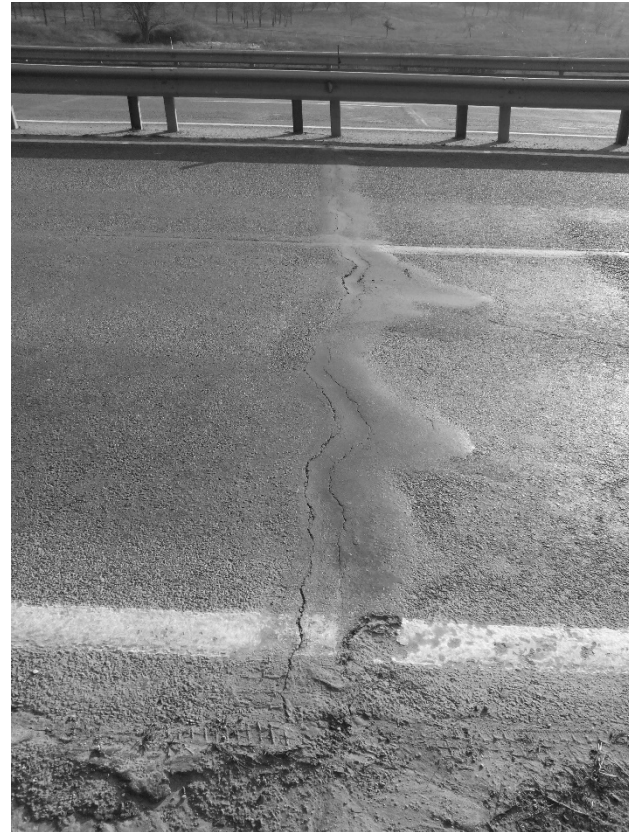
Figure 6. Transversal cracks in the road surface. December 2019.
