Opportunities for rehabilitation of facades of historic buildings in Moldova with limestone elements

D C Albu¹ and A Lesan²

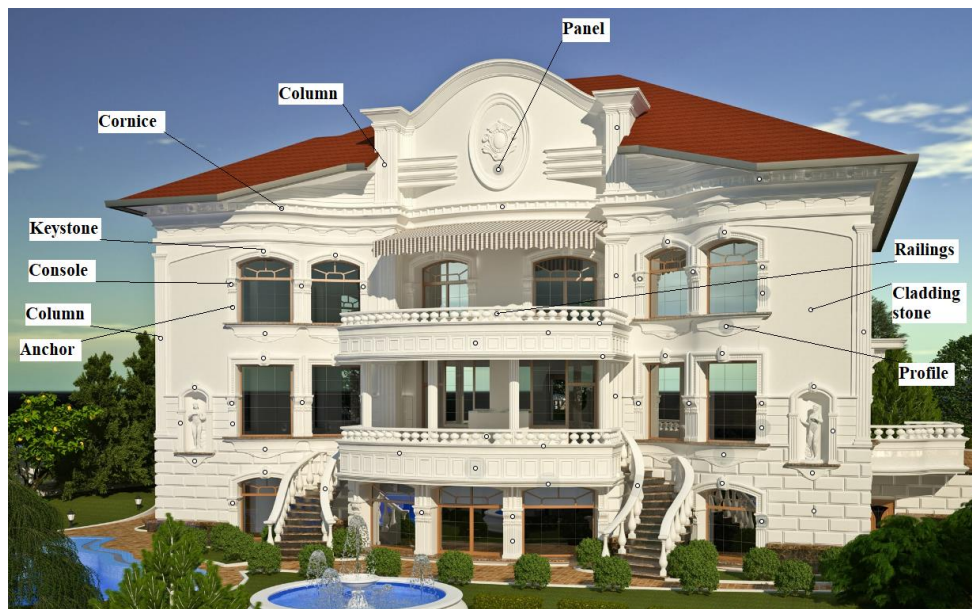
Figure 1. Limestone elements for façade.

Figure 1 shows the basic limestone elements of a facade, which can be custom-made depending on the architectural style of the historical building.

From an architectural point of view, various elements shown in Figure 1 can be rehabilitated using limestone.
